Robert W. Williams and Associates
Consulting Arborists

Jonh Trethewey, Association Property Manager

3 / 13 / 17

The periodic assessments of the trees takes place so that representatives of the community and their management team can act to best manage the assessed risk associated with the trees, minimize harm, and implement their duty of care. This is the report of the periodic inspection which took place during early March of 2017.

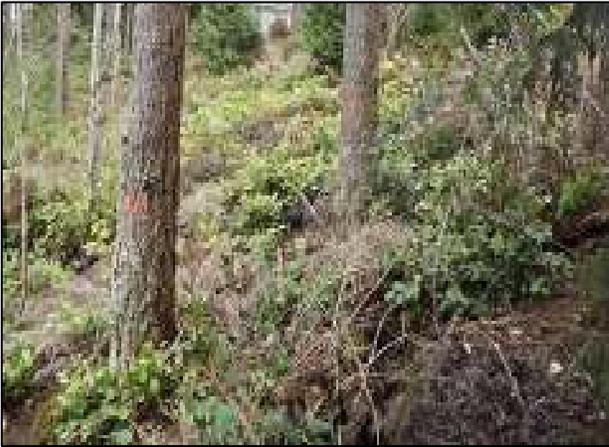
- Two Douglas fir marked for removal or snagging to a safe height. Resonance testing gave indication of internal decay; one tree shows wounding at the base. The trees are located at the base of the NGPA buffer adjacent to the residence at 3113 201st Place SE
- An Alder Group (shown in the photograph above right) is beginning to outgrow and lean heavily towards the play area that is located on the entrance road to the cul de sac at 201st Place SE. Selective removal of leaning or overgrown trees is recommended.

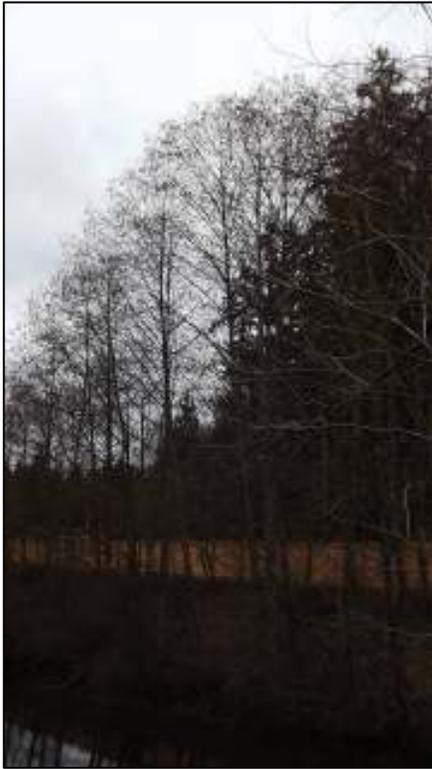
tree. Both are edge trees within the NGPA buffer, behind and close to the fence line of the residence at 20022 34th Avenue SE. The fir, shown at right is codominant and is flagged with yellow tape. Removal of the smaller, secondary leader is recommended. To the north is a smaller tree, flagged with fluorescent green tape. This tree should be removed or snagged to a safe height.

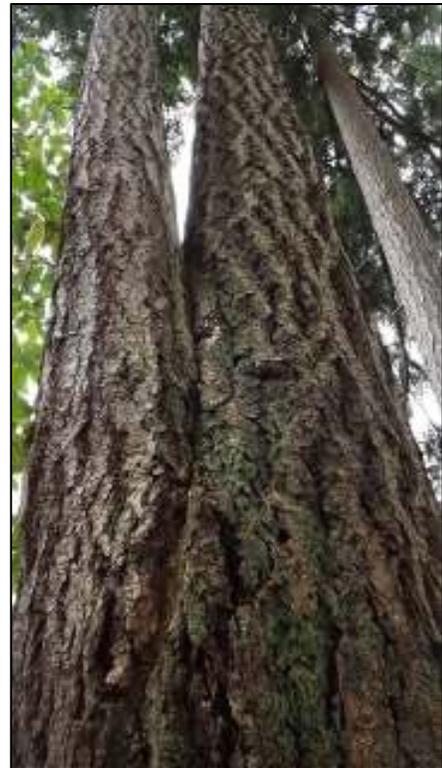
- Two additional Douglas fir are recommended for removal or snagging to a safe height. These trees are severely decayed and in decline. They are in the NGPA buffer down slope, painted with orange marking; behind the residence at 3328 200th Place SE

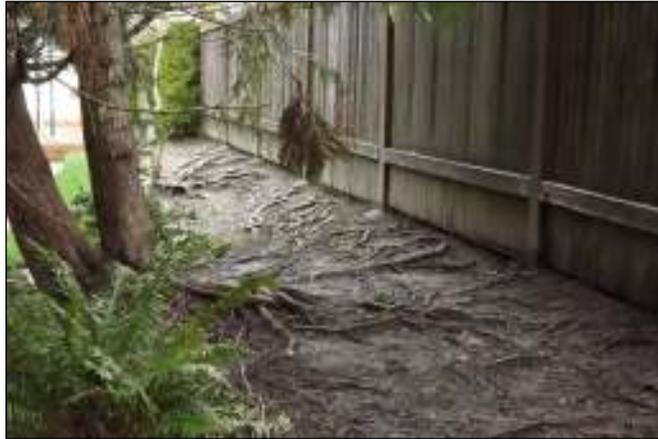
As a separate issue, areas of concern were observed previously in several locations, for example, the shrubs and trees growing adjacent to the Play Area on 200th PI SE next to the residence at 3106. The topsoil in this area has been washed,

eroded or blown away and sub-surface rooting conditions are likely compacted and hostile to deeper root growth.

Where roots are now exposed replacement of the soil with fertile mulch is recommended.

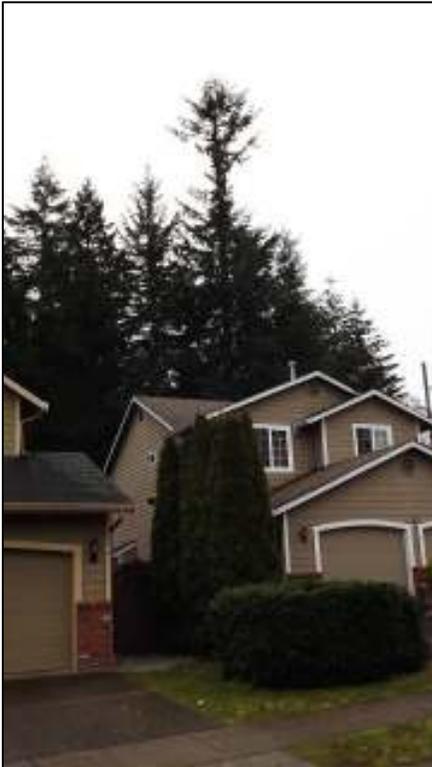
Lastly a large, dominant Douglas fir, in the NGPA buffer, behind and adjacent to the residence at 3014 200th Place SE is showing signs of decline. Given the size and significance of this tree, the condition should be reviewed toward the end of this year's growing season.
