Robert W. Williams and Associates
Consulting Arborists

Jonh Trethewey, Association Property Manager

3 / 13 / 17

The periodic assessments of the trees takes place so that representatives of the community and their management team can act to best manage the assessed risk associated with the trees, minimize harm, and implement their duty of care. This is the report of the periodic inspection which took place during early March of 2017.

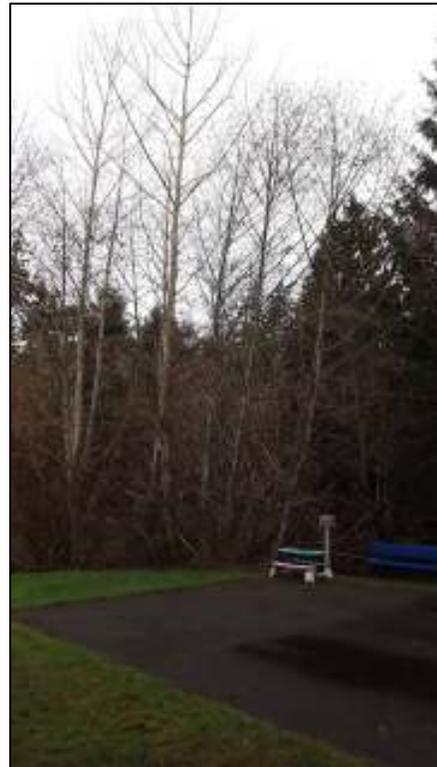
- Several Alder and Cottonwood trees within the Detention Pond area show indications of potential stem or whole tree failure. As the crowns become heavier, recurring failure is predicted. Selectively thin by removal or snagging of the larger trees. In this area, debris should be completely removed to keep the area free from impacts to the pond's functionality.
- Two Douglas fir were flagged with fluorescent green or yellow tape stapled to the

tree. Both are edge trees within the NGPA buffer, behind and close to the fence line of the residence at 20022 34th Avenue SE. The fir, shown at right is codominant and is flagged with yellow tape. Removal of the smaller, secondary leader is recommended. To the north is a smaller tree, flagged with fluorescent green tape. This tree should be removed or snagged to a safe height.
